## AVIATION INVESTIGATION REPORT

A01O0157

### ENGINE STOPPAGE ON TAKE-OFF

CESSNA 172N SKYHAWK C-GMHU

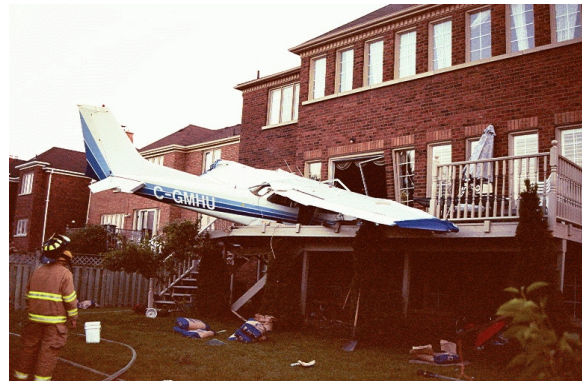
**Figure 1 - Aircraft resting on deck**

During the take-off and the initial climb, the pilot did not observe any abnormalities except that the carburettor heat control knob was slightly extended. He pushed the control knob in and kept his hand on it to ensure that it stayed fully in (OFF). He did not detect any degradation of power before the engine stoppage. During the forced approach, the pilot attempted two engine restarts without success. He then moved the fuel selector to OFF before impact. The aircraft turned left toward a residential area and struck a house approximately 1.4 nautical miles west-northwest of the Toronto / Buttonville Municipal Airport, Ontario. After the aircraft came to rest on the back deck of the house (Figure 1), one of the occupants of the house assisted the pilot in exiting the aircraft. The aircraft windshield broke during the crash, and the pilot exited through the front of the aircraft. Numerous suitable forced landing sites were available off the departure end of Runway 33 had the aircraft continued straight ahead or altered course slightly to the right.

The aircraft was removed from the residential area and examined at the Toronto / Buttonville Municipal Airport. While documenting the aircraft cockpit, it was noted that the fuel selector was OFF. All other controls and switches (mixture, magnetos, and master switch) were in the engine operating position and had not been moved. Damage to the fuel selector mechanism indicated that the fuel selector was OFF at impact. The aircraft fuel tanks were compromised at impact, and an undetermined amount of fuel leaked onto the residential yard. The local fire department responded to the scene, and the fuel remaining in the tanks was captured and contained. The propeller bent rearward when it struck the deck; there was no indication of propeller rotation.

After the engine stopped, directional control of the aircraft was not maintained, and the aircraft turned left and crashed in a residential area. This occurred when the pilot removed his hand from the control column during his attempts to restart the engine. Because of the low altitude at which the engine stopped, the pilot believed that he did not have sufficient time to conduct the appropriate emergency checklist. He concentrated his efforts on restarting the engine to the detriment of maintaining aircraft control, completing the appropriate checklist items, and conducting an effective forced approach and landing.
